NON-DESTRUCTIVE TESTING REPORT

FOR
RCC SCHOOL BUILDING
BELONGS TO
SPRING DALE INTERNATIONAL SCHOOL

**BYE LANE: 3, SONKUCHI PATH, BEHARBARI CHARALI,
NH-37, GUWAHATI - 781029, ASSAM**

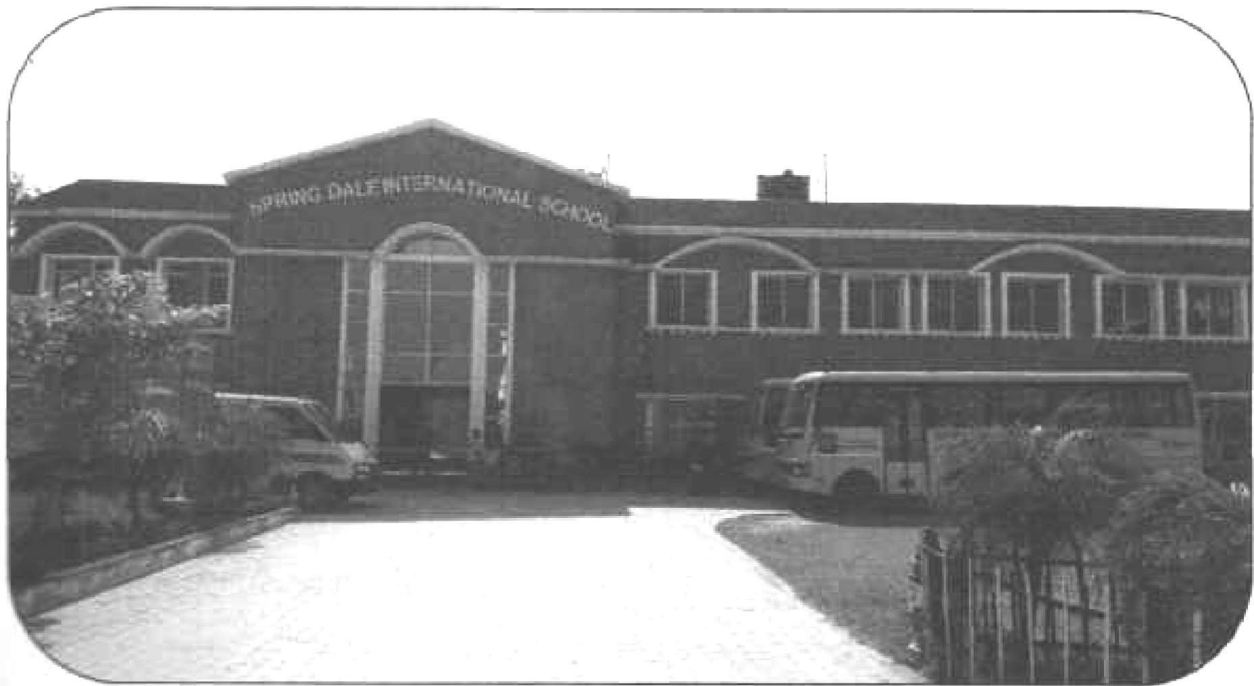
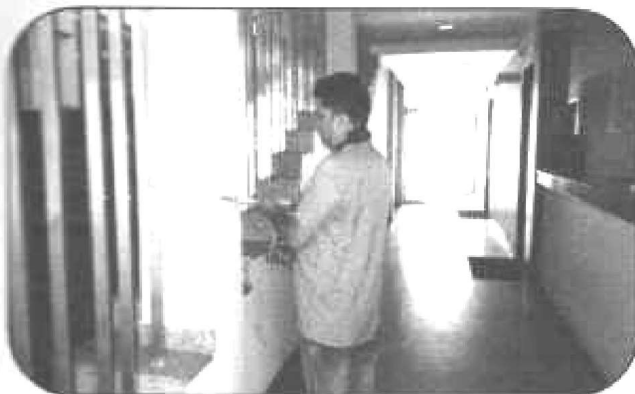
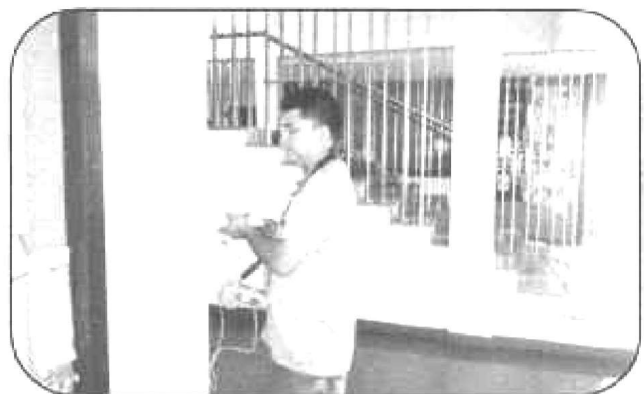
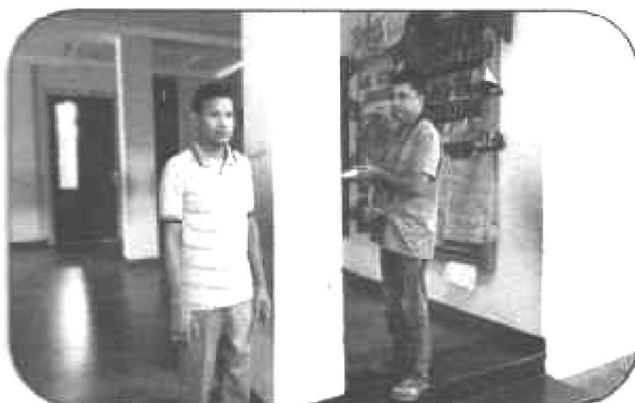
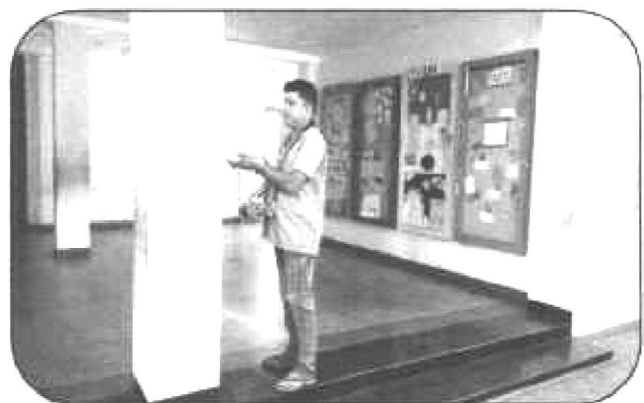
Testing Photographs Spring Dale International School

Field work (field testing) is done by the EREC Staff with the help of NDT Equipments. For detection of strength Schmidt Hammer (ND Type) & UPV are used for quality checking of the building.
